Final Report
on

# Establishing the Leakage Rates of Mobile Air Conditioners

(B4-3040/2002/337136/MAR/C1)

Prepared for the
European Commission (DG Environment)

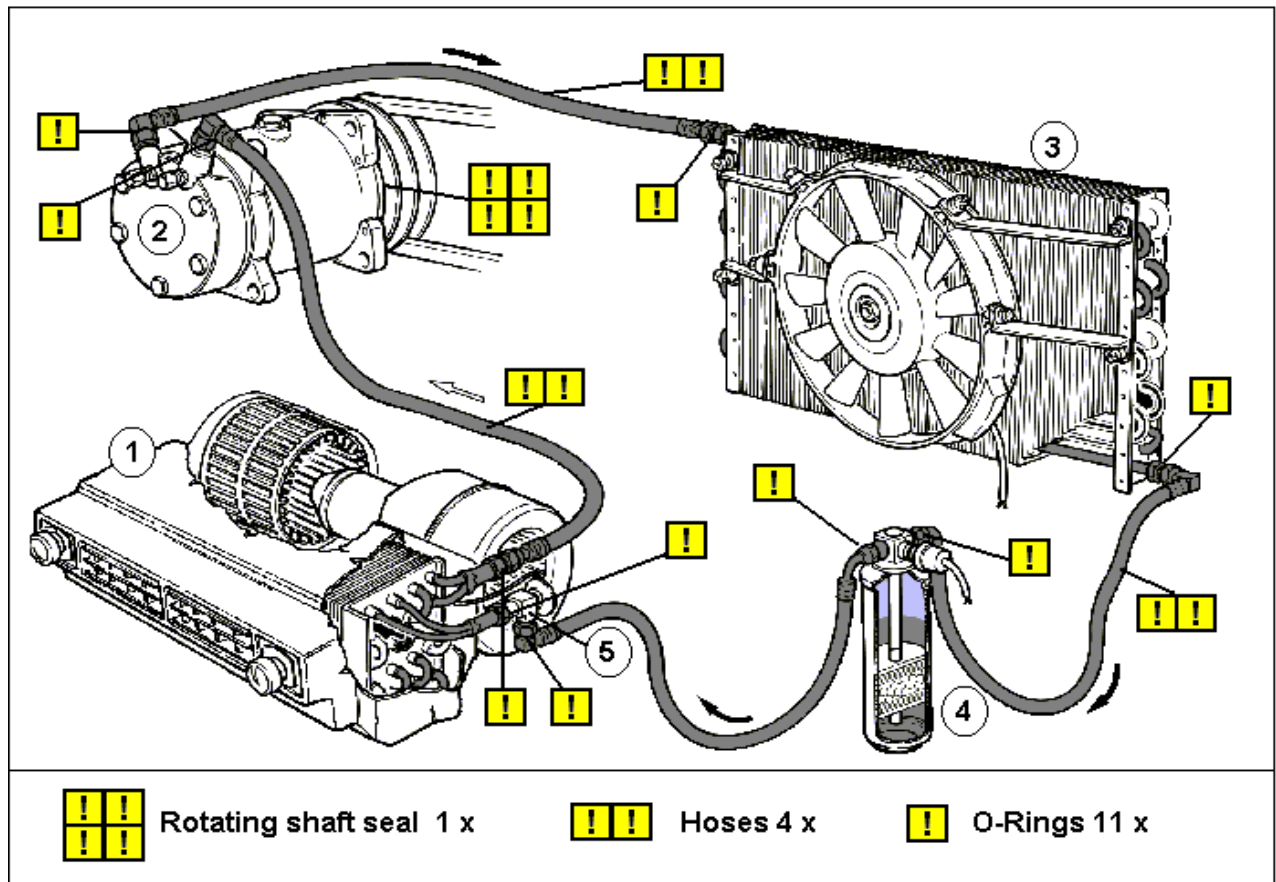
**Figure 2: MAC and its weak spots leading to a gradual steady loss of HFC-134a in a range tolerated by car manufacturers (over 15 grams/yr.) The refrigerant circuit: 1 = Evaporator. 2 = Compressor. 3 = Condenser. 4 = Receiver/Drier. 5. Expansion valve.**

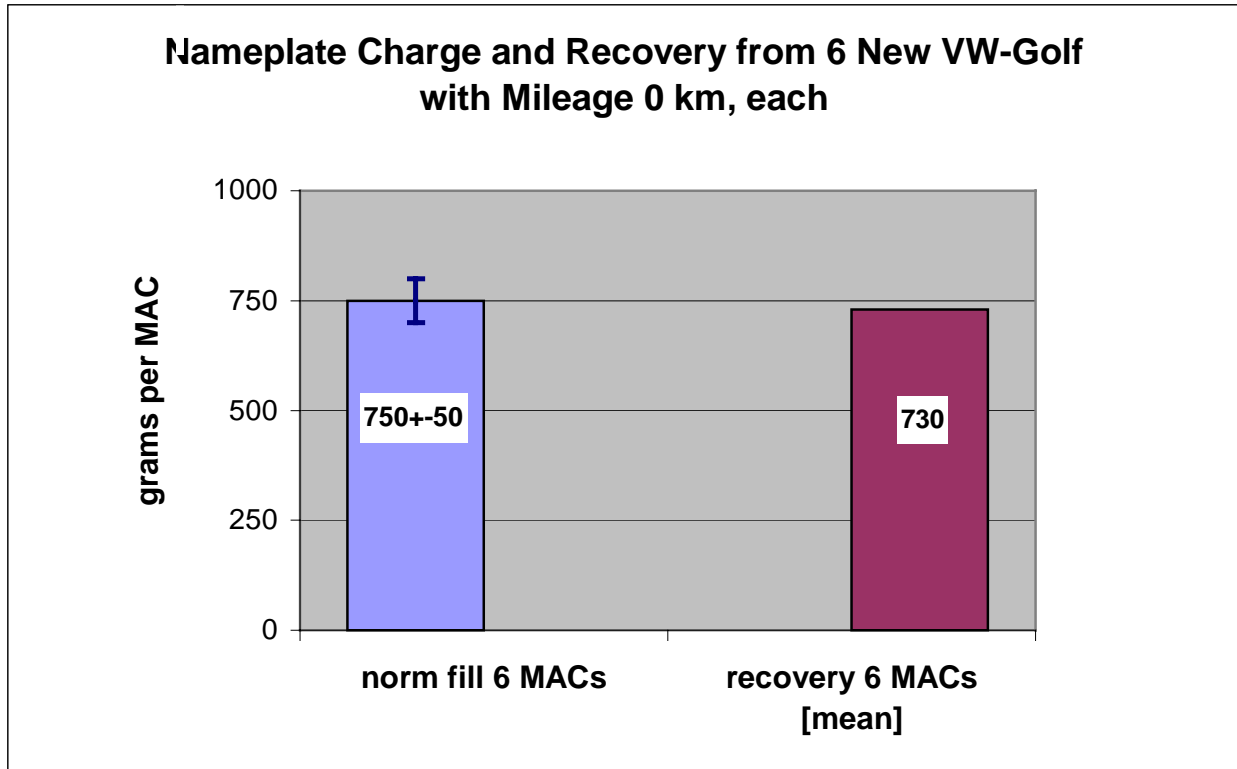
**Figure 5: Norm charge and recovery from 6 new VW-Golf with mileage 0 km, each. The left bar shows the full charge - with tolerance band, the right bar shows the mean recovery. The mean difference is 20 grams, meaning 20 grams unrecoverable by means of the measuring equipment used.**

The six vehicles were measured by means of the recovery stations Waeco RHS 650 and Waeco RHS 500. The ambient temperature was 17 °C. The average duration of a recovery cycle was 23.3 minutes.

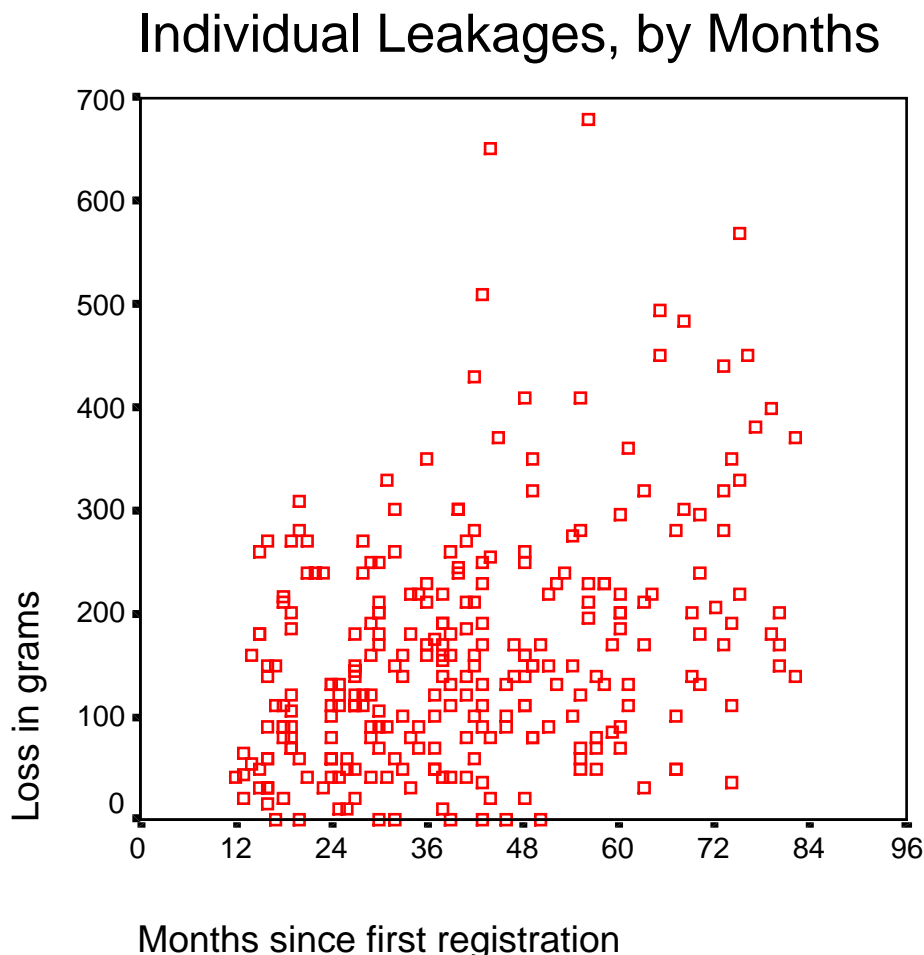
**Figure 10: The MAC leakages in months since first registration. The data points of the 276 loss rates show a principal direction going from bottom left to top right.**

Obviously, refrigerant losses do not take an identical course in every single MAC. There are too many influencing factors. For instance, the duration of time for which individual systems remain switched on over the lifetime of a vehicle can be expected to vary widely, even in the same climatic region, from about 50 to more than 250 hours per annum in Europe. Then, the life of a vehicle's engine (as it undergoes vibration and the development of heat), actually a more important aspect in the context of regular leakage, also varies widely from about 100 to more than 800 hours - and this is not allowing for mileage and for traffic conditions. Another factor would be the driver's personal driving habits, which will have a varyingly stressful effect. Again, the way the MAC is operated by the owner and used has a part to play, and the ambient temperature co-determining a system's pressure is not the same for every unit (car garaged or parked in the open). Moreover, the quality of workmanship in one MAC is not absolutely the same as in the next.

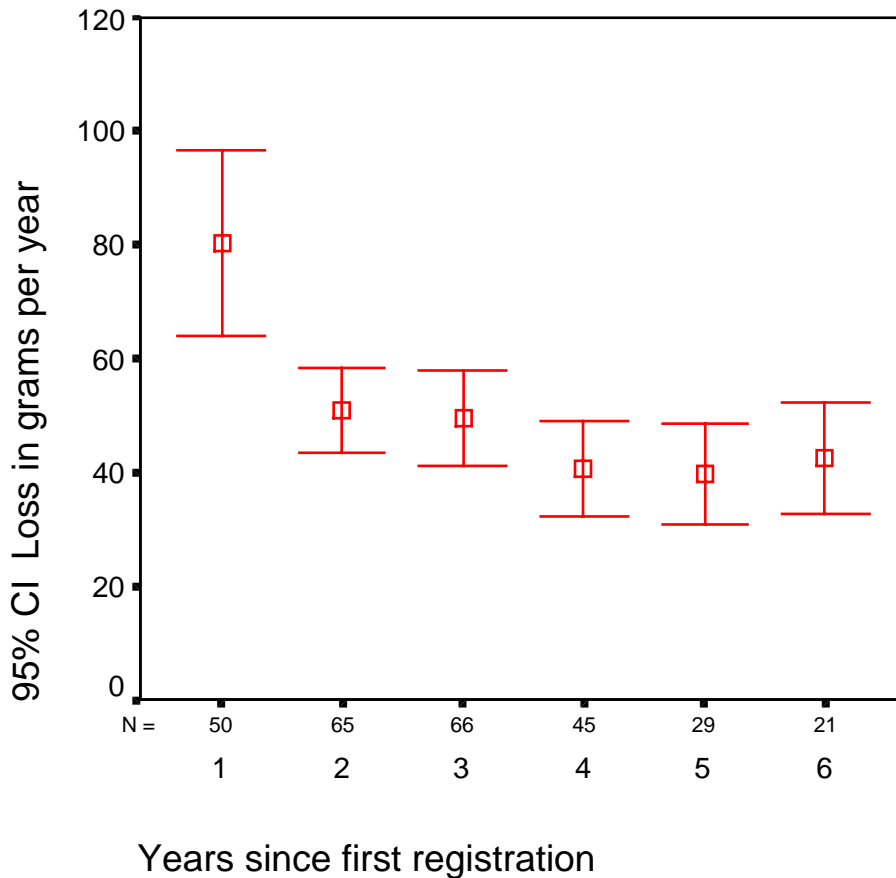
**Figure 11: Average annual leakage rates, by years since first registration. Unlike the high figure of the year 1-2, the following five annual leakage rate show a relatively high uniform picture. All the figures are located between 40 and 50 grams**

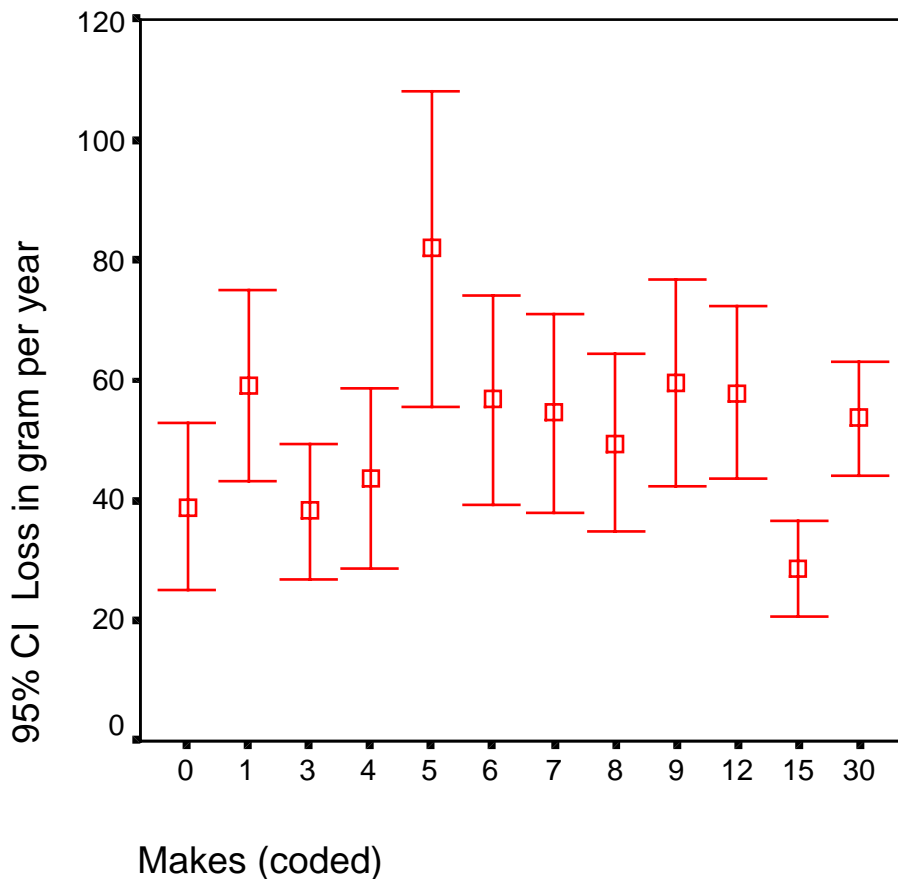
**Figure 12: Regular annual leakage rates by makes (coded). The 12 different makes or make-groups show significant differences from each other. Car manufacturer 15 has the lowest average annual leakage rate of 28.8 (±5.3) grams/yr, while car manufacturer 5 has the highest 81.9 (±24.4) grams/yr.**

While the average annual leakage rate was 52.4 grams/yr the MACs of several car manufacturers were higher than this figure. The highest was 81.9 grams. Car manufacturer "5" had an annual leakage rate that was estimated to be 60% higher than the average, or three times higher than the best performer (car manufacturer "15"). It seems evident that the design and quality of components used by manufacturers differ a lot and consequently the leakage of HFC-134a vary considerably.
